Site survey – Mgungundlovu eMakhosini Ulundi

Site Survey – Mgungundlovu eMakhosini Ulundi – Elize Becker Archaeology Section

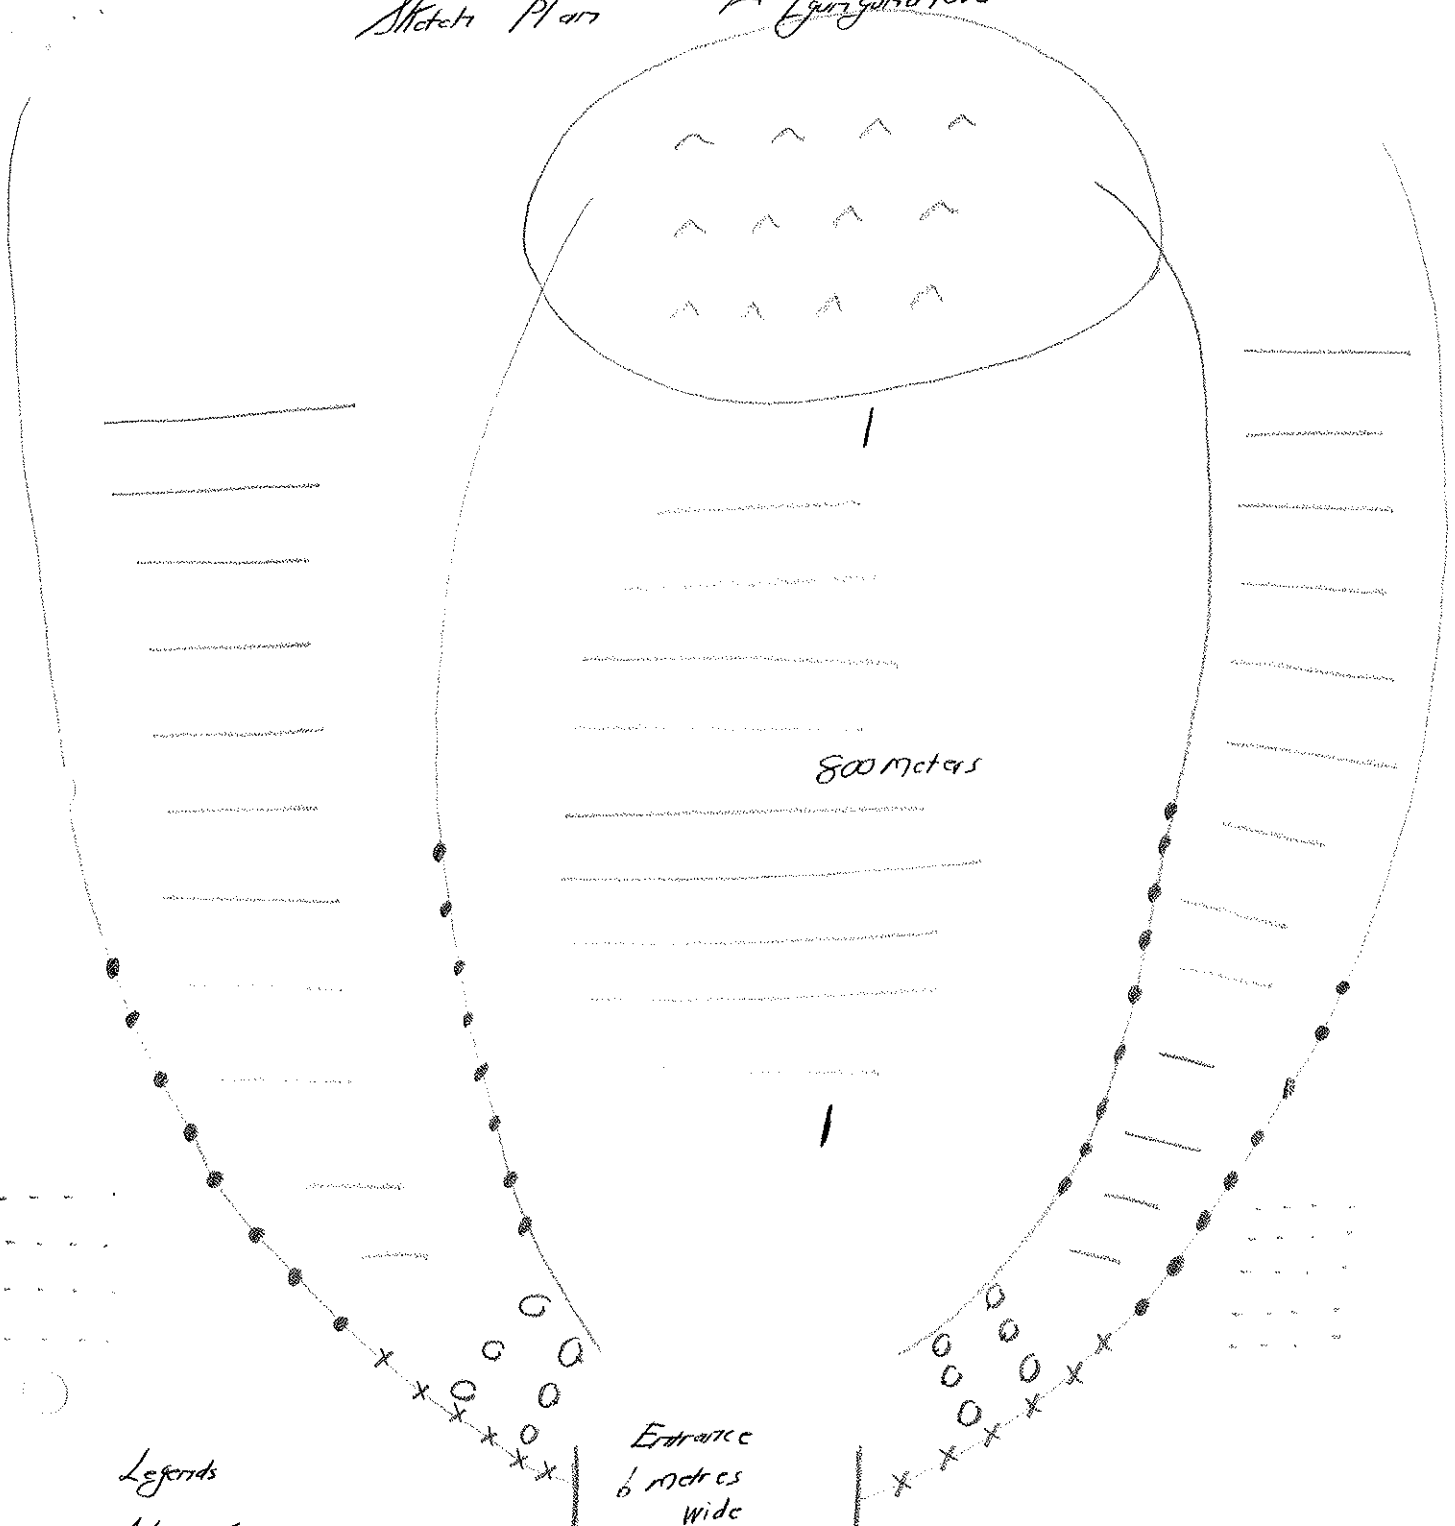
Sketch Plan A Jurgundlovu

The place of hut structures will be approximately 800 metres from Dingaan's Hut. A fence will be placed around the existing and new hut structures that will include Aloe Trees and Pole structures.

1. The reconstruction of hut structures at the outer boundaries of the location.
2. Planting of Aloe Trees to create a fence alignment.

3. Clearing of vegetation 800 metres from the original structures.
